**Flood Control Project Maintenance
Levee Inspections**

Maintenance Issue Types Only, Levee Inspection Report By Mile - Spring 2017

Sutter Maintenance Yard Hamilton Bend

| Waterway | Bank | Unit Miles | Inspection Start/End | Inspector |
|---|---|---|---|---|
| Unit No. 01 Feather River Hamilton Bend | Right | 3.39 | 03/23/2017 03/23/2017 | Sterling York |

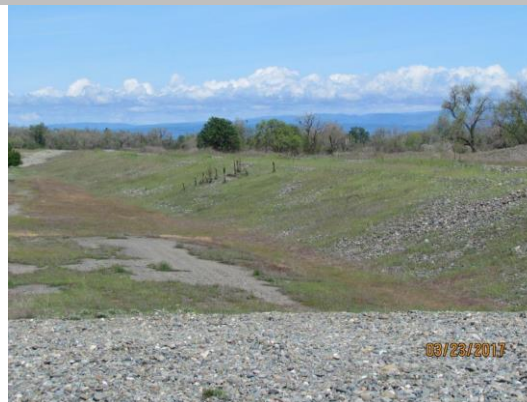
Photo 1 of 1 : SP_2017_ST0005_289_12_20170327_00016.jpg

| Controlled annual vegetation. | | | | | |

View of well maintained vegetation, land side looking upstream. Spring 2017.

| V1 : Control annual grass and weeds on the levee slopes and easements. | | | | | |

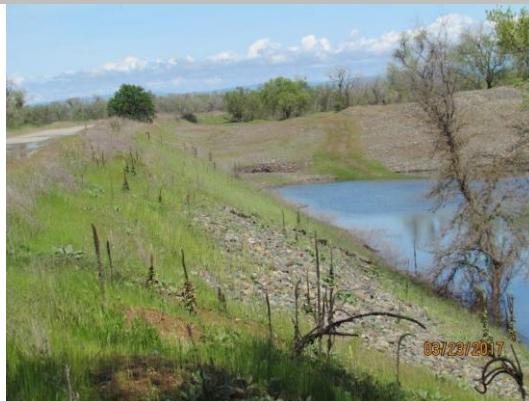
Photo 1 of 1 : SP_2017_ST0005_289_17_20170327_00017.jpg

| Controlled annual vegetation. | | | | | |

View of well maintained vegetation, water side looking upstream. Spring 2017.

| V1 : Control annual grass and weeds on the levee slopes and easements. | | | | | |

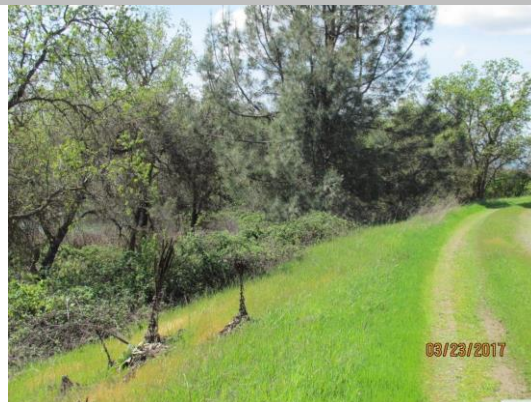
Photo 1 of 1 : SP_2017_ST0005_289_18_20170327_00020.jpg

| From Levee Mile 1.38 to 3.39 has never been maintained by the LMA | | | | | |

View of thick trees and vegetation blocking visibility on waterside, looking downstream. Spring 2017.

| T3 : Trim and thin trees to allow visibility of the ground and room to flood fight. | | | | | |

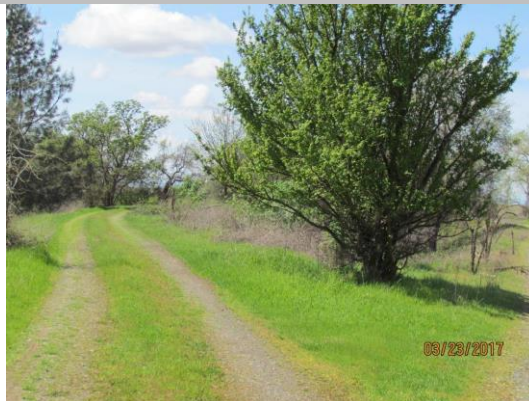
Photo 1 of 1 : SP_2017_ST0005_289_11_20170327_00019.jpg

| From Levee Mile 1.38 to 3.39 has never been maintained by the LMA | | | | | |

View of thick trees blocking visibility on landside, looking downstream. Spring 2017.

| T3 : Trim and thin trees to allow visibility of the ground and room to flood fight. | | | | | |

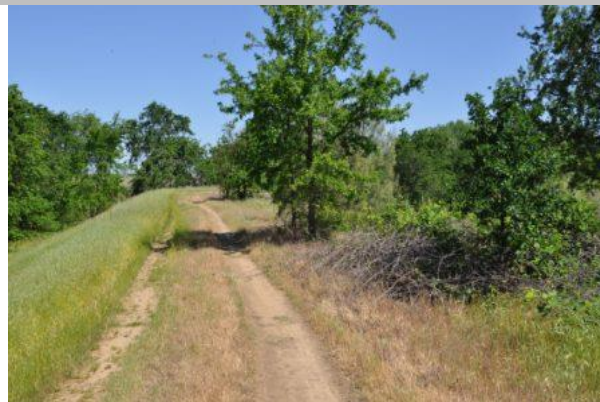
Photo 1 of 1 : SP_2017_ST0005_289_5_20170316_00003.jpg

| Trees smaller than 4" in diameter at chest height should be removed before they get any bigger. | | | | | |

W/S trees 4" in diameter at chest height should be removed before they get to big..

| T1 : Trim trees to at least five feet above ground level. | | | | | |

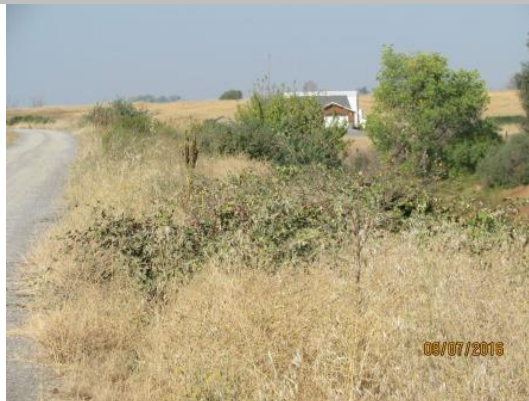
Photo 1 of 1 : SP_2017_ST0005_289_10_20170316_00005.jpg

| Blackberry bushes are covering landside slope. From Levee Mile 1.38 to 3.39 has never been maintained by the LMA. | | | | | |

View of blackberries that are covering landside slope.

| V2 : Remove the wild growth other than native grasses from the levee slopes. | | | | | |

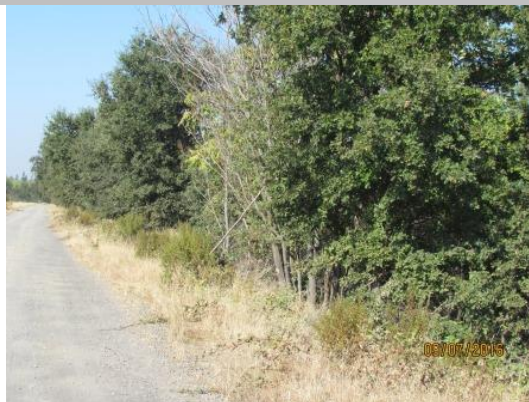
Photo 1 of 1 : SP_2017_ST0005_289_3_20170316_00001.jpg

| From Levee Mile 1.38 to 3.39 has never been maintained by the LMA | | | | | |

Very dense trees and limbs that completely obstruct visibility and flood fight access to the levee slope and the landside easement.

| T2 : Thin trees to allow visibility of the ground and room to flood fight. | | | | | |

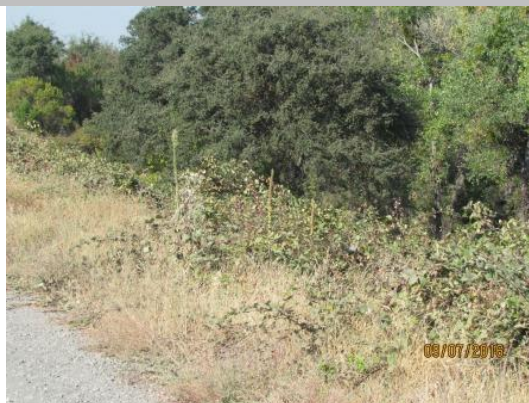
Photo 1 of 1 : SP_2017_ST0005_289_6_20170316_00004.jpg

| Blackberries covering slope. From Levee Mile 1.38 to 3.39 has never been maintained by the LMA. | | | | | |

View of blackberries that are covering the landside slope.

| V2 : Remove the wild growth other than native grasses from the levee slopes. | | | | | |

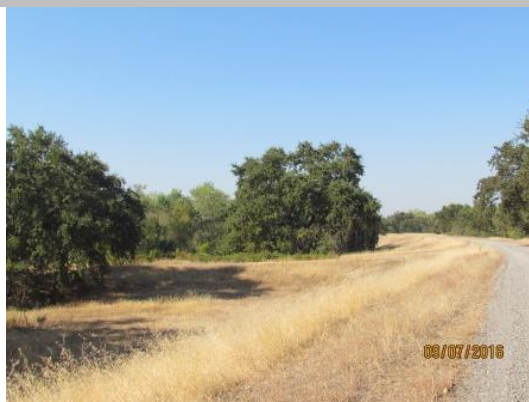
Photo 1 of 1 : SP_2017_ST0005_289_23_20170316_00009.jpg

| Annual grasses need to be maintained. From Levee Mile 1.38 to 3.39 has never been maintained by the LMA. | | | | | |

View of annual grasses that need to be maintained.

| V1 : Control annual grass and weeds on the levee slopes and easements. | | | | | |

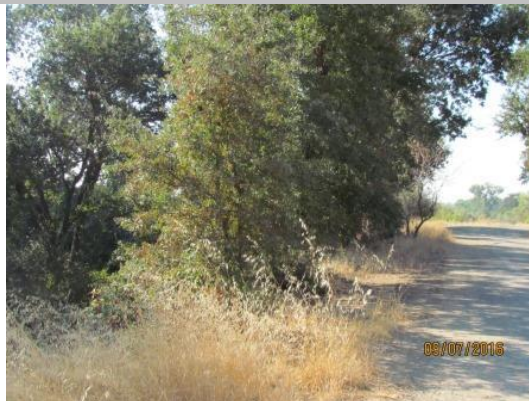
Photo 1 of 1 : SP_2017_ST0005_289_4_20170316_00002.jpg

| Small trees 4" in diameter at chest height should be removed before they get too big. From Levee Mile 1.38 to 3.39 has never been maintained by the LMA. | | | | | |

Waterside trees. Small trees 4" in diameter at chest height should be removed before they get to big.

| T3 : Trim and thin trees to allow visibility of the ground and room to flood fight. | | | | | |
